## **Demonstration and Validation of Materials for Corrosion-Resistant Fencing and Guard Railings in Aggressive Climates**

Final Report on Project F09-AR02

Christopher Olaes, Richard G. Lampo, and Lawrence Clark

October 2015

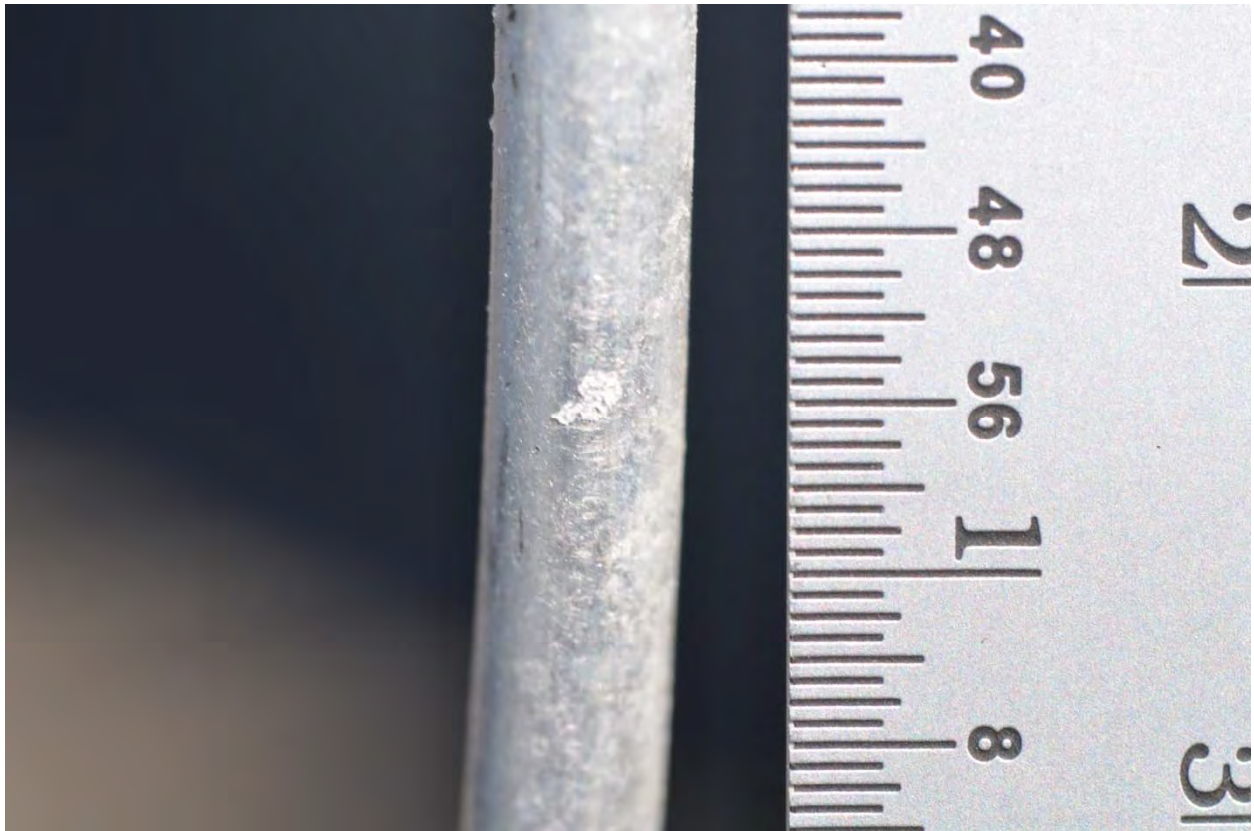
Each wire coupon had visible deposit of chlorides from the salt water environment.

*Figure B168. Aluminum Wire Coupon*

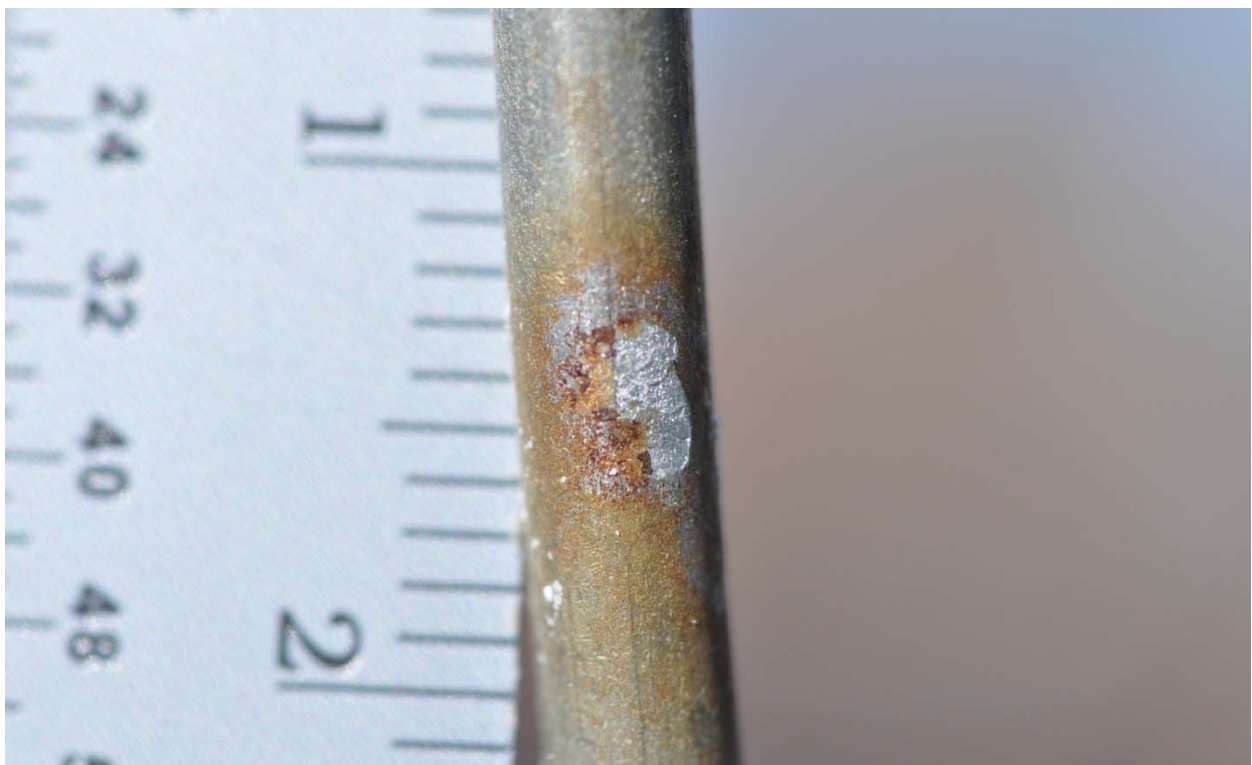
*Figure B169. Stainless Steel Wire Coupon*

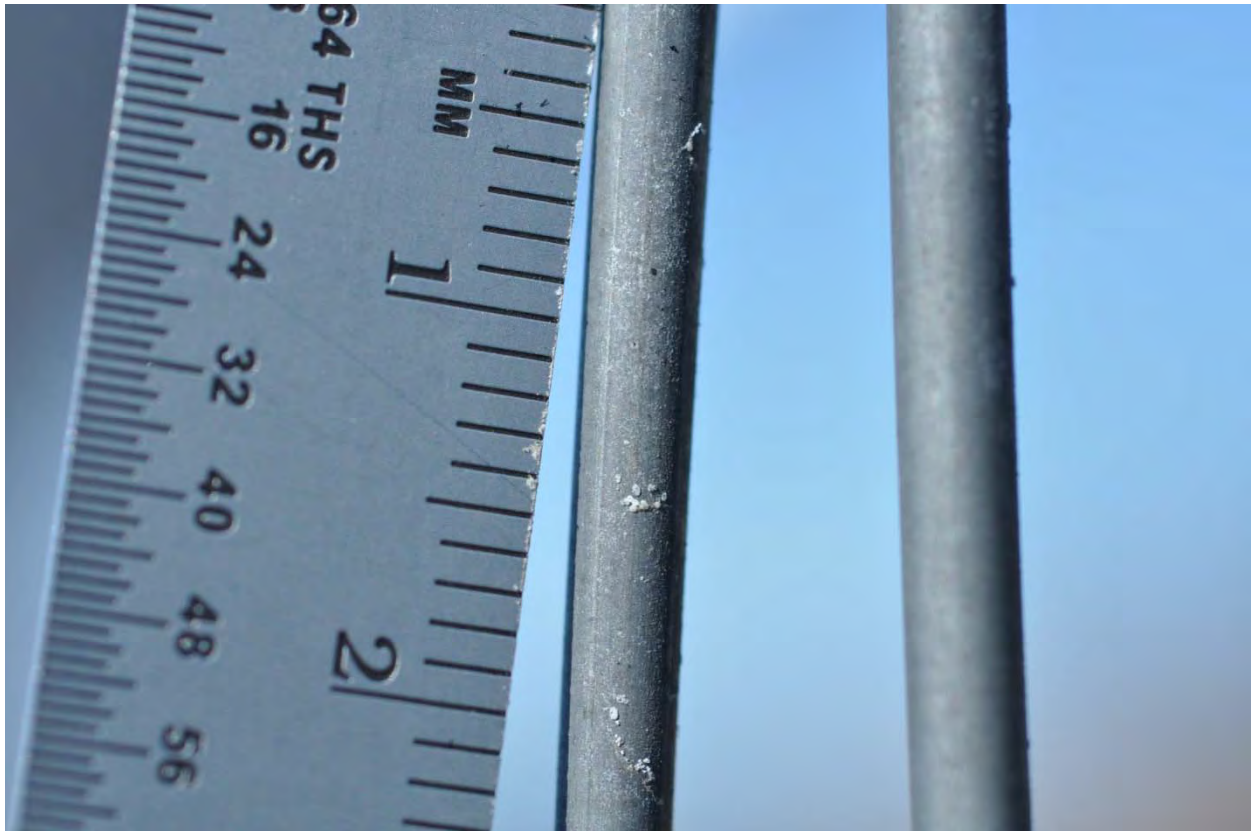
Figure B170. Galfan Wire Coupon

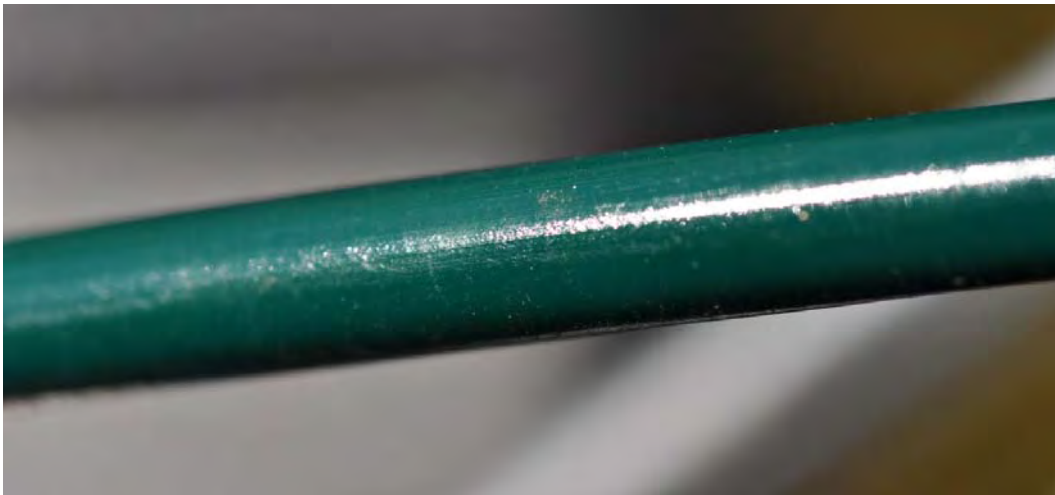
*Figure B175.* Standard PVC Coated Galvanized Wire Coupon

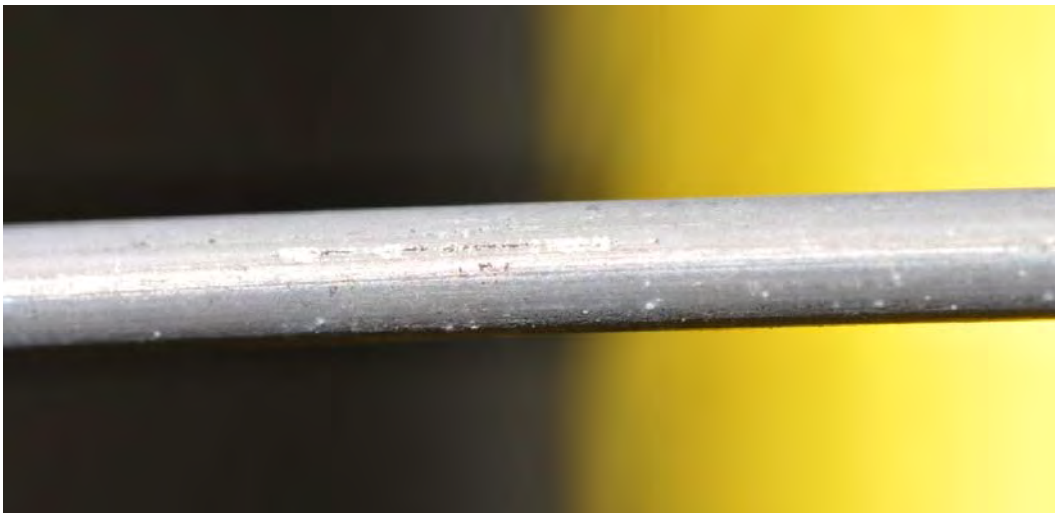
*Figure B176.* Standard Galvanized Wire Coupon

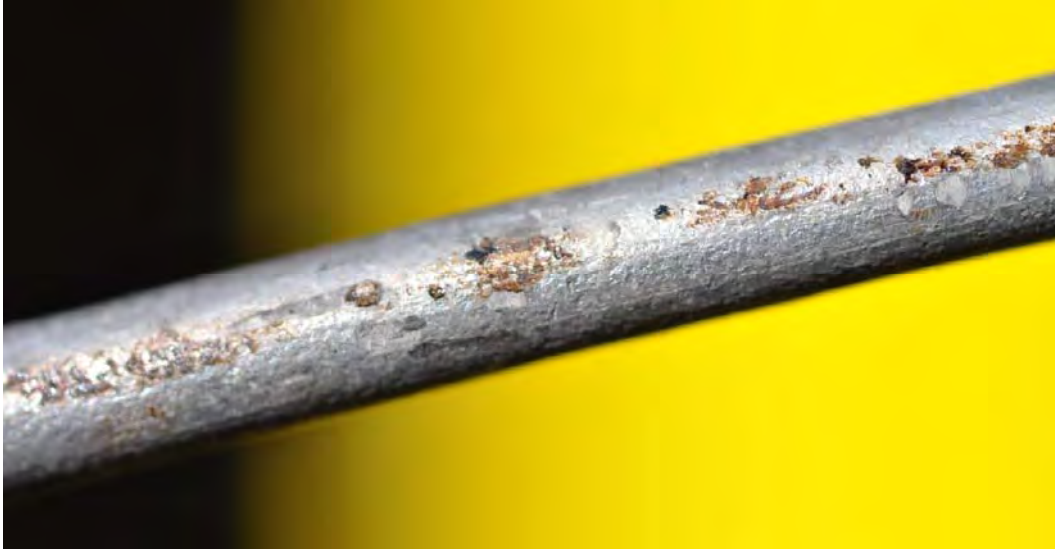
*Figure B177. Aluminized Steel Wire Coupon*

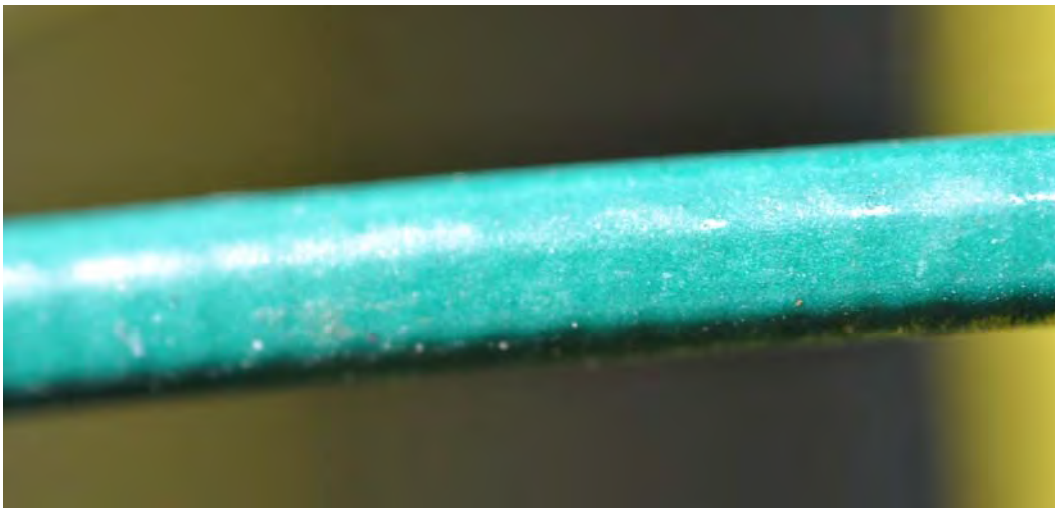
*Figure B178. Fuse Bonded PVC Coated Galvanized Wire Coupon*

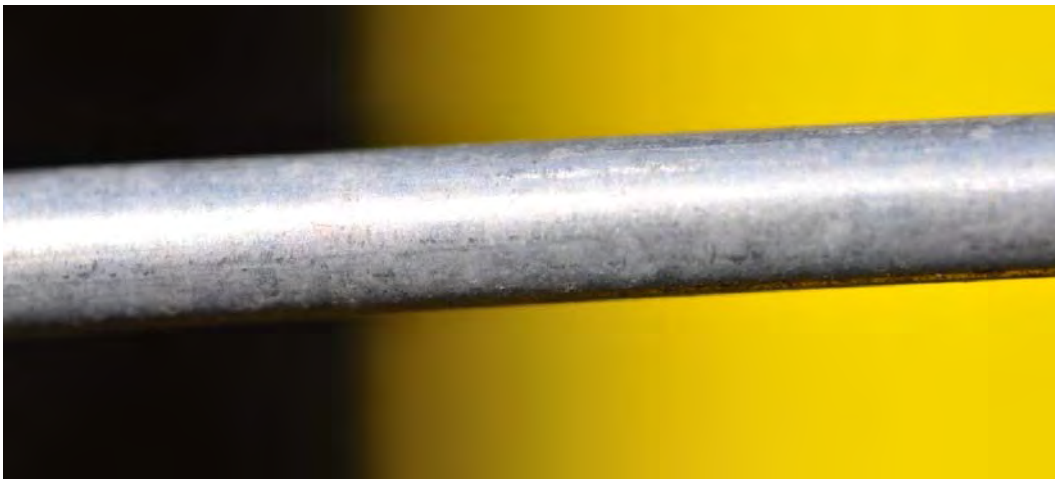
*Figure B179. Aluminum Wire Coupon*

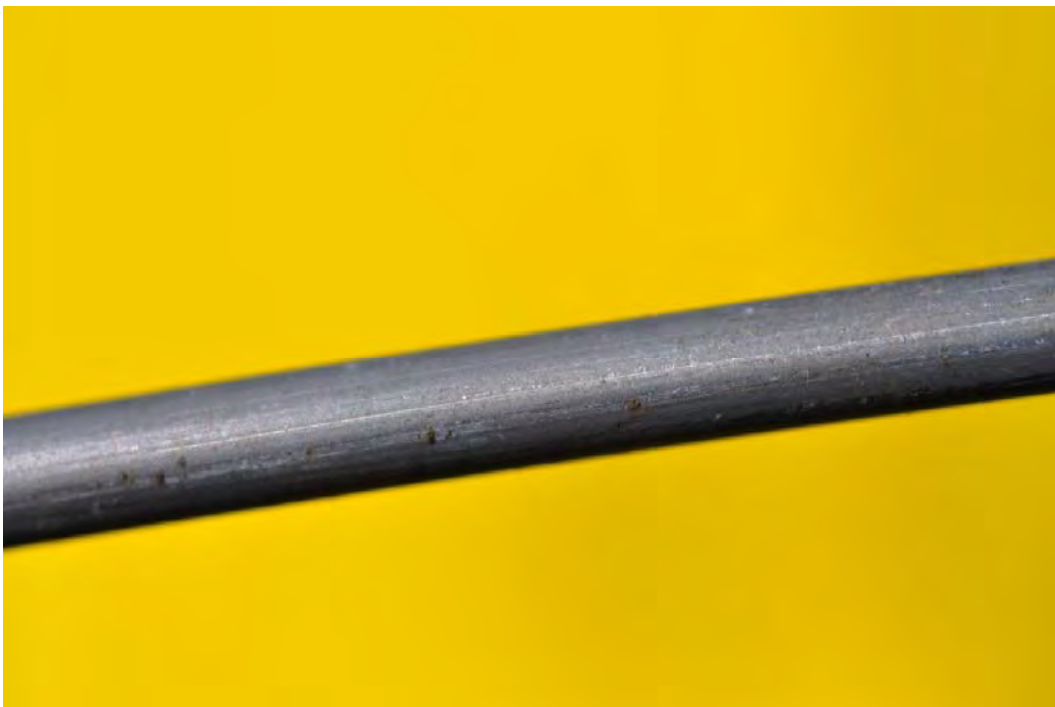
*Figure B181.* Galvan Wire Coupon
